REPORT AND PRELIMINARY RESULTS OF R/V POSEIDON CRUISE POS472

NORGEOTECH

GEOTECHNICAL IN SITU INVESTIGATION OF SLOPE STABILITY IN
NORWAY

TRONDHEIM (NORWAY) – TROMSØ (NORWAY)
27.07.2014 – 12.08.2014

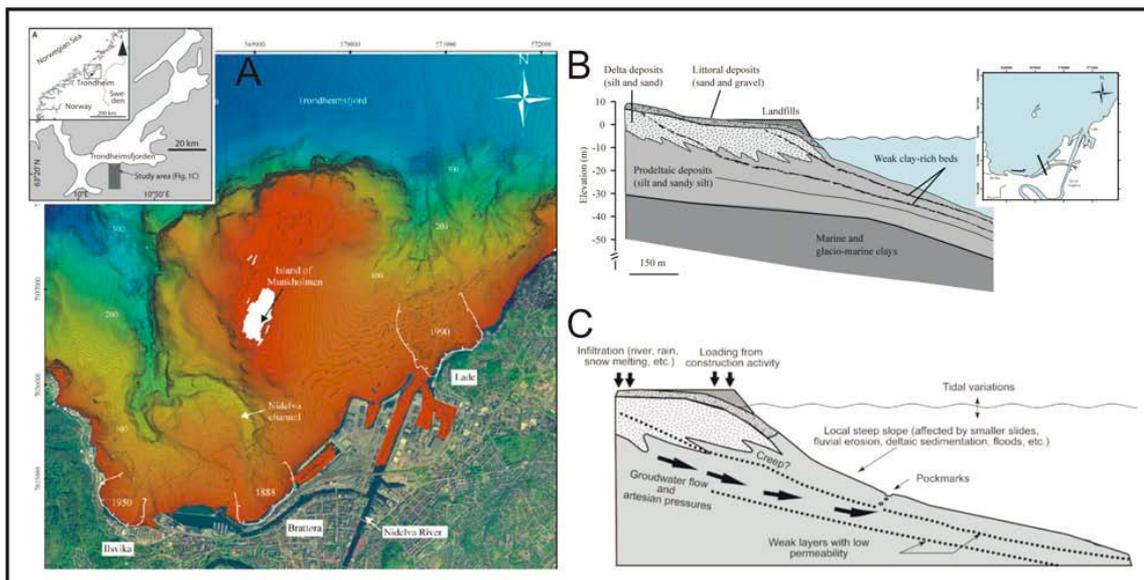
Figure 4 Location of the Trondheim Fjord in central Norway. White lines indicate the landslide scars of the different failure events in 1888, 1950, 1990 (L'Heureux et al. 2011) b) Schematic cross-section of the sedimentological build-up of the Nidelva Delta (L'Heureux et al. 2011). The position of the profile is shown by the black line in the inset map; c) conceptual model of fluid migration (L'Heureux et al. 2011)

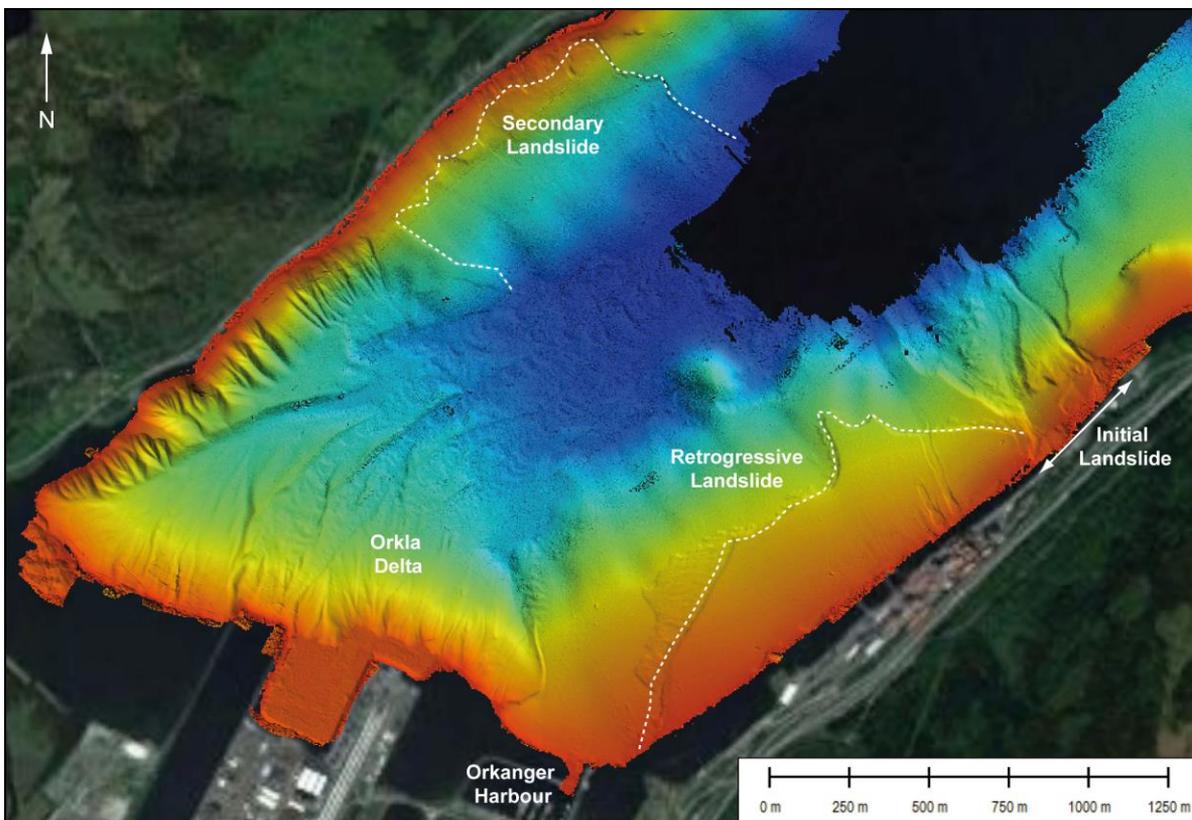
Figure 5 The 1930 Orkdalsfjorden failure affected the southeastern flank of the fjord. The event was activated close at the shoreline from the area, where the collapse was initially activated to Along the southwestern flank of Orkdalsfjorden the headwall of the 1930 landslide stretches from the area, where the initial landslide was activated to the failure affecting Orkanger Harbour (L'Heureux et al. 2014).

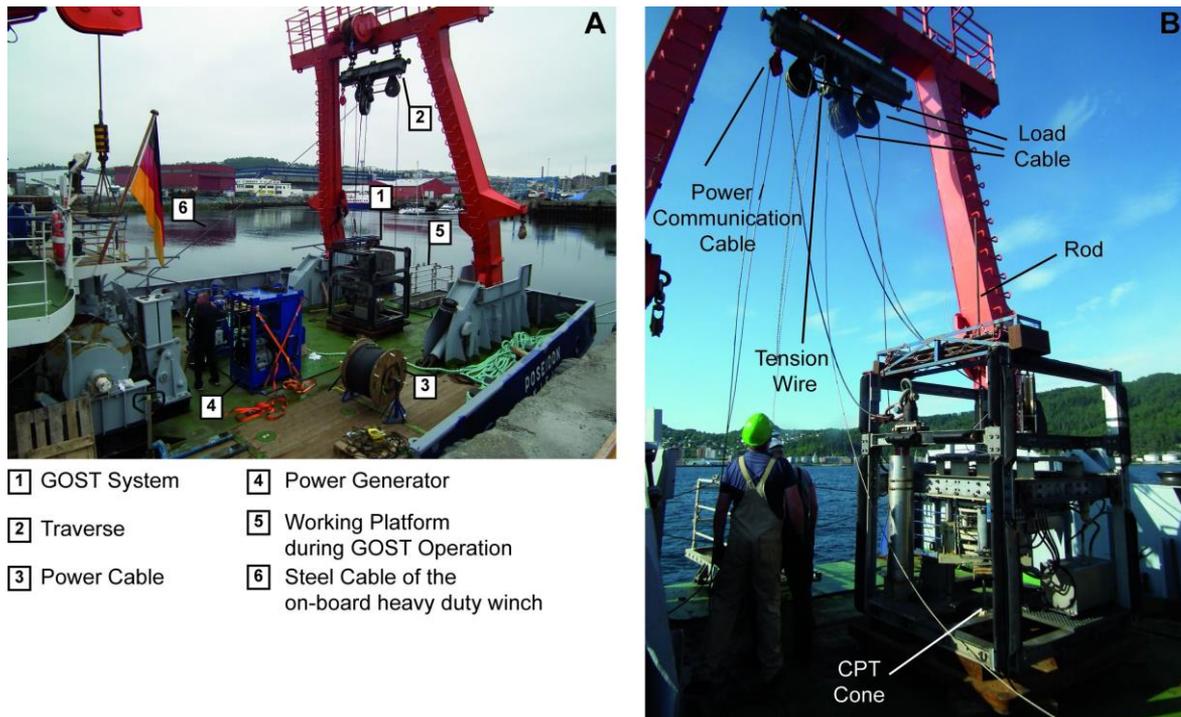
Figure 8 Setup of the GOST system on R/V Poseidon

water column (Figure 8). During POS472 the length of the mounted rod was 20 m, which defined the maximum penetration depth. In the course of operation the rod was held upright by a constant-tension winch from the ship (Figure 8). When GOST reached the seafloor the CPTu probe is pushed quasi-statically into the soil with a penetration velocity of 2 cm/s in increments of 25 cm.

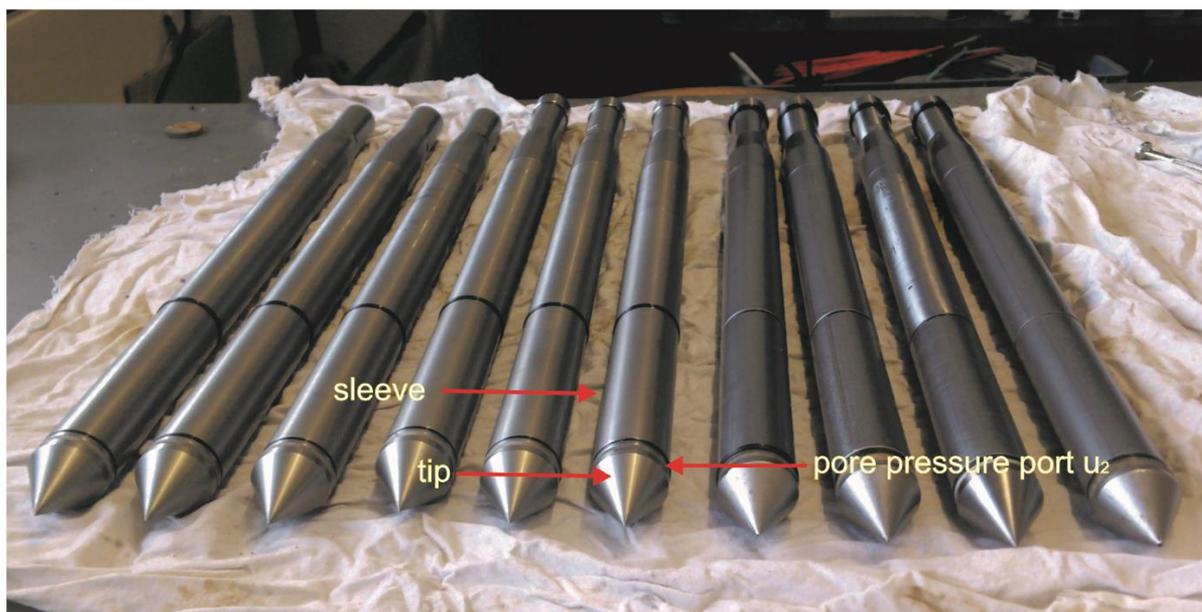
Figure 9 Digital pressure-compensated compression CPTu cones, as installed in the GOST system.

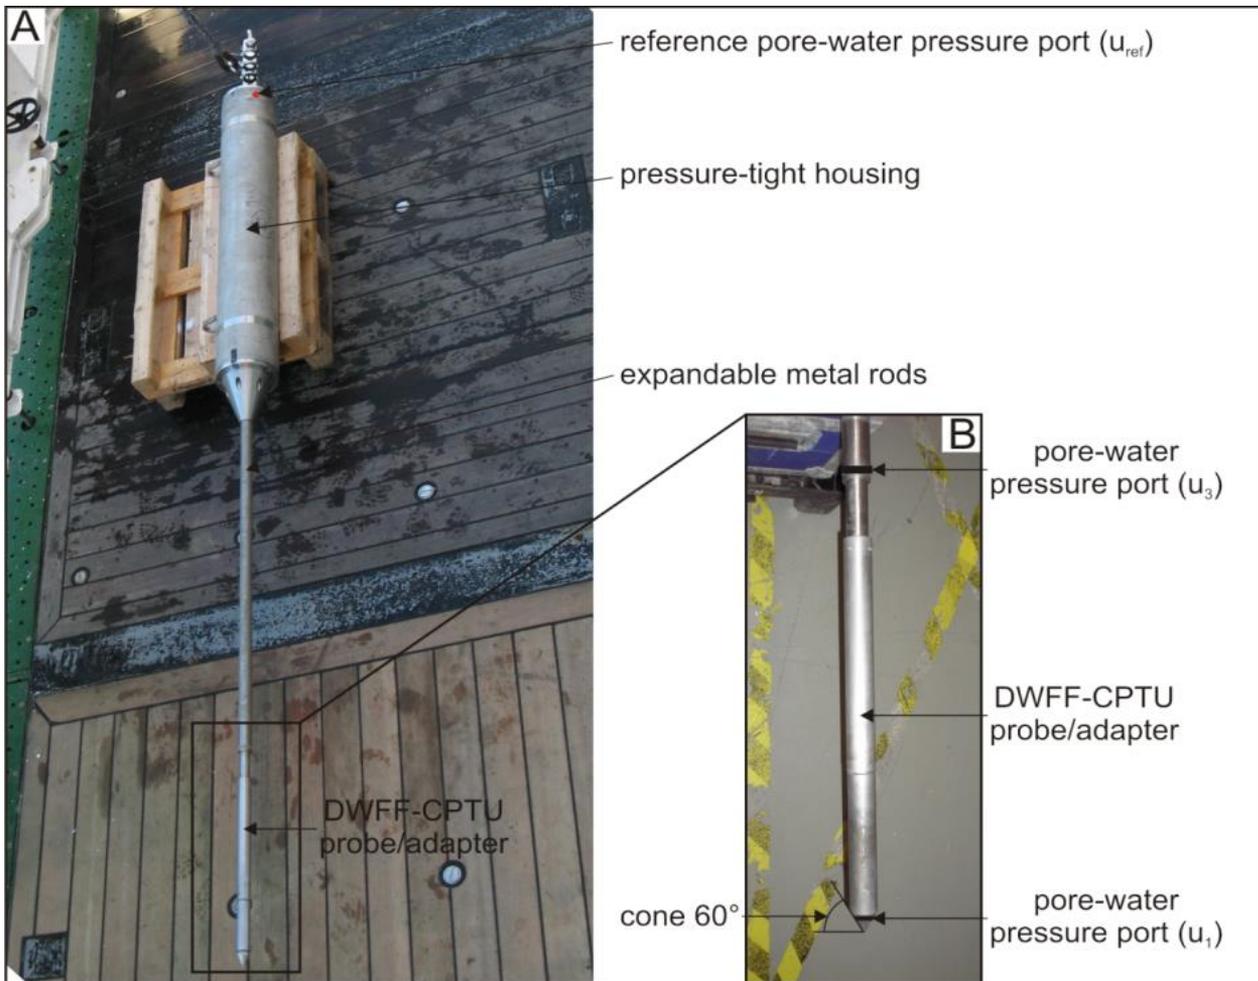
Figure 10 Deep-water FF-CPTu instrument (A). Panel (B) shows blow up of the frontal portion with the pore pressure ports.

The free-fall CPTu (FF-CPTu) instrument for deep water (DW) (up to 4000 m water depth) use consists of a 15 cm² CPT cone manufactured in the MARUM working group Marine Geotechnics and a water-proof housing containing a microprocessor, volatile memory, battery, and accelerometer (see Figure 10A; and Stegmann and Kopf, 2007 for details). The CPTu cone measures cone resistance and is equipped with two pore pressure port (u_1 and u_3). The stainless steel pressure-tight housing containing a microprocessor, standard secure digital memory card (SD), tiltmeter, accelerometer, power supply (battery packages), absolute and differential pore-water sensors as well as power and data interface module (PDIM). The tiltmeter (dual-axis tilt sensor) monitors the penetration angle at $\pm 45^\circ$ relative to vertical. Five different accelerometers with different ranges ($\pm 1.7g$, $\pm 18g$, $\pm 35g$, $\pm 70g$ and $\pm 120g$) provide information about the de/acceleration behaviour of the DWFF-CPTU instrument upon penetration. Acceleration data allow the researcher calculation of penetration velocity and depth by 1st and 2nd integration. The reference pore-water pressure port at the pressure-tight housing is equipped with an absolute 40 MPa (400 bar) pressure sensors (*WIKA ECO-1*). The pore-water pressure ports at the tip (u_1) and 0.75 m behind the tip (u_3) are connected to the differential pore-water pressure transducers (*VALIDYNE P55D*) via stainless steel tubing. Pore-water pressure changes can be monitored over a range of 85 kPa (12.5 PSI) to 140 kPa (20.0 PSI) with a resolution between 8.0 - 15.0 Pa. The sensors are protected with valves if high excess pore-water pressures are met (e.g. owing to blocked hydraulic tubes). They are further used to bleed the tubing in case of gas is trapped inside, especially during the initial phase of deployment when the instrument is lowered through the water column.

The DW-FF-CPTu instrument is used in an autonomous mode, at which all sensor and transducer information will be recorded on a standard secure digital memory card (SD) with a very high sampling frequency (up to 1 kHz) using an AVISARO microcontroller. The frequency of data acquisition is variable depending on the operation mode (e.g. sub-seafloor profiling or pore-water pressure dissipation test) as well as the penetration rate of the DWFF-CPTU test. After the CPTu operation the data are downloaded via W-LAN to a PC. Two non-volatile battery packs available performance times of about eight to twelve hours, respectively. A self-developed deck interface box is used to download the recorded data and to charge the battery packs.

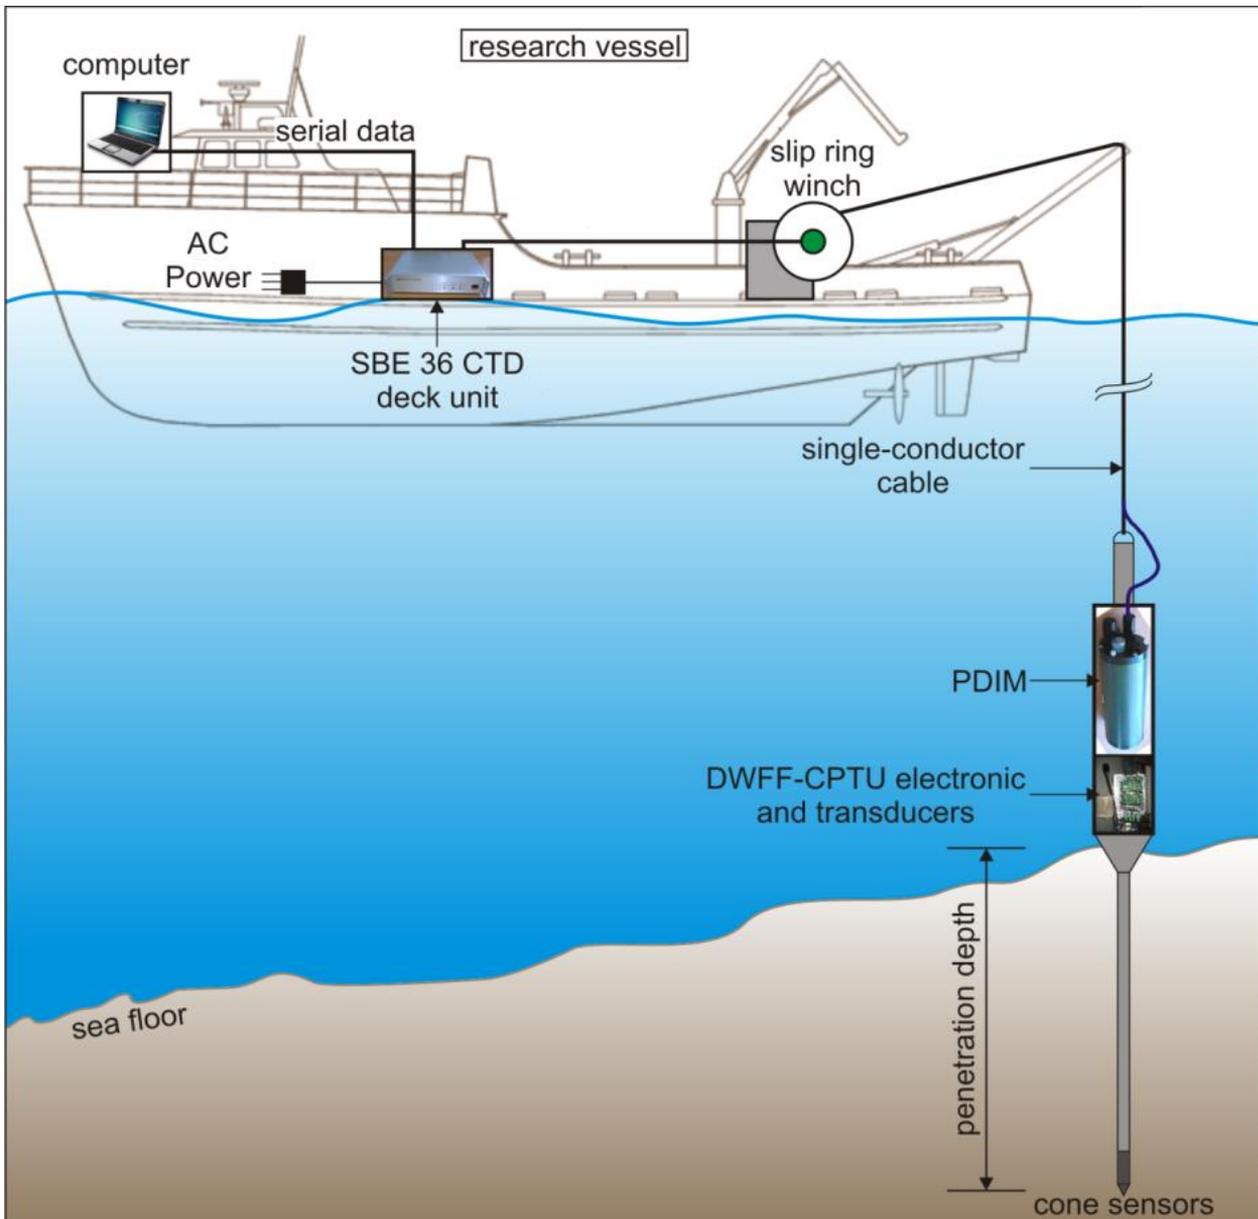
Figure 11: Schematic of SBE36 CTD and PDIM telemetry system.

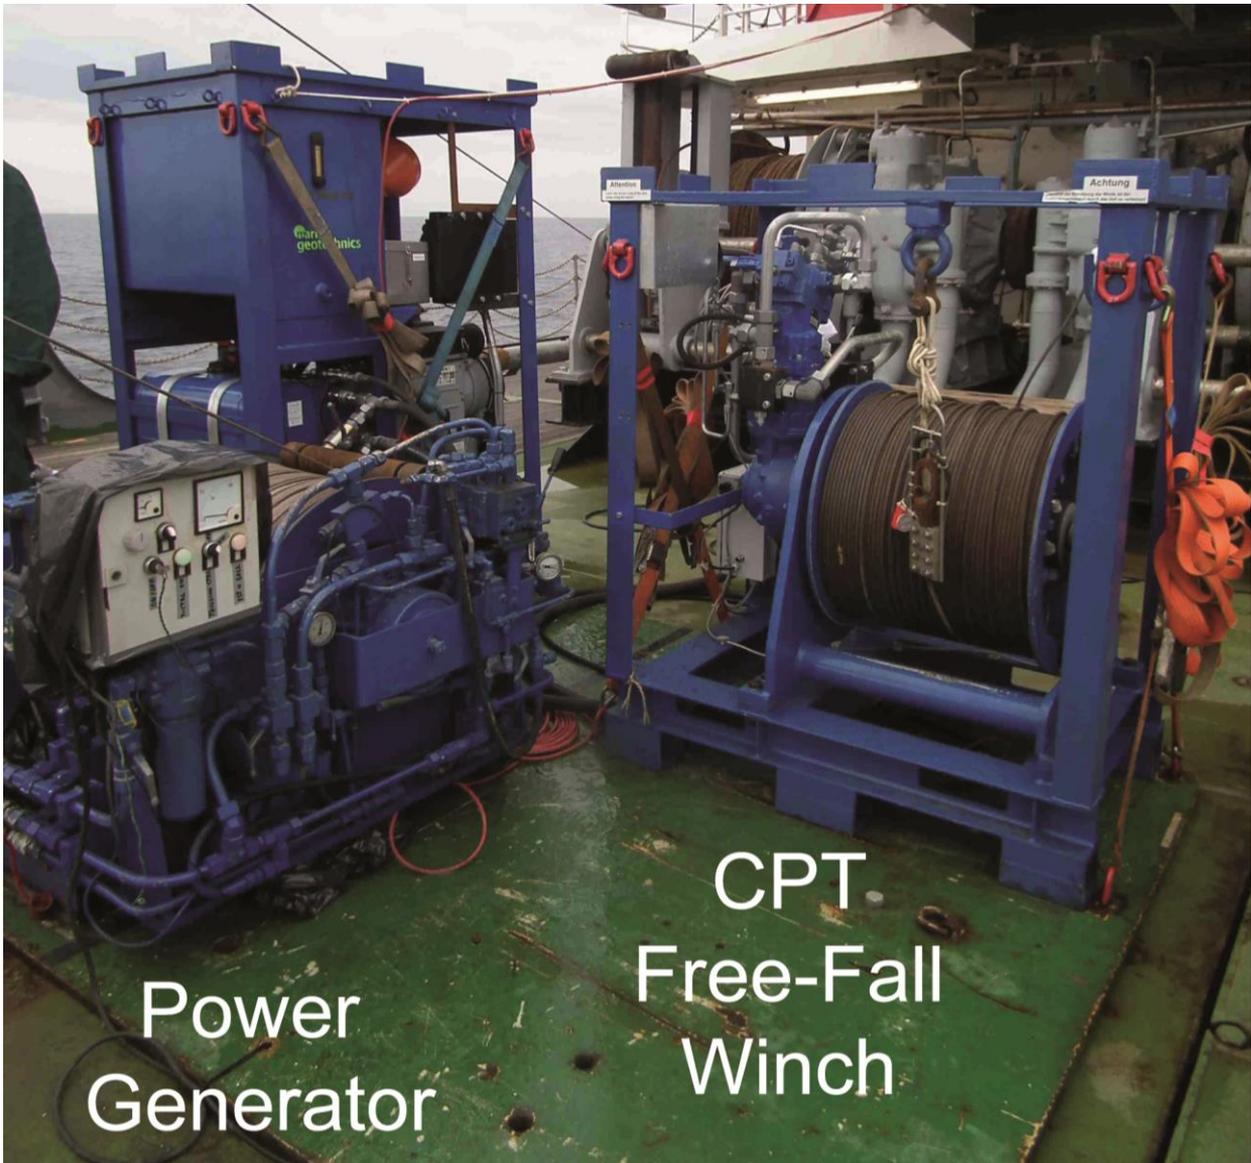
Figure 12 New MARUM FF-CPTu-Winch 200 m (left) and entire assembly together with hydraulic aggregate (right).

The winch as well as the aggregate is designed with a footprint of a standard Euro-palette, and the winch itself can be put either next to the aggregate, or on top of it (see Figure 12). The frame is equipped with leashing points, where the winch was fixed on the working deck of RV POSEIDON. Electrical power was provided by the aggregate of the GOST system.

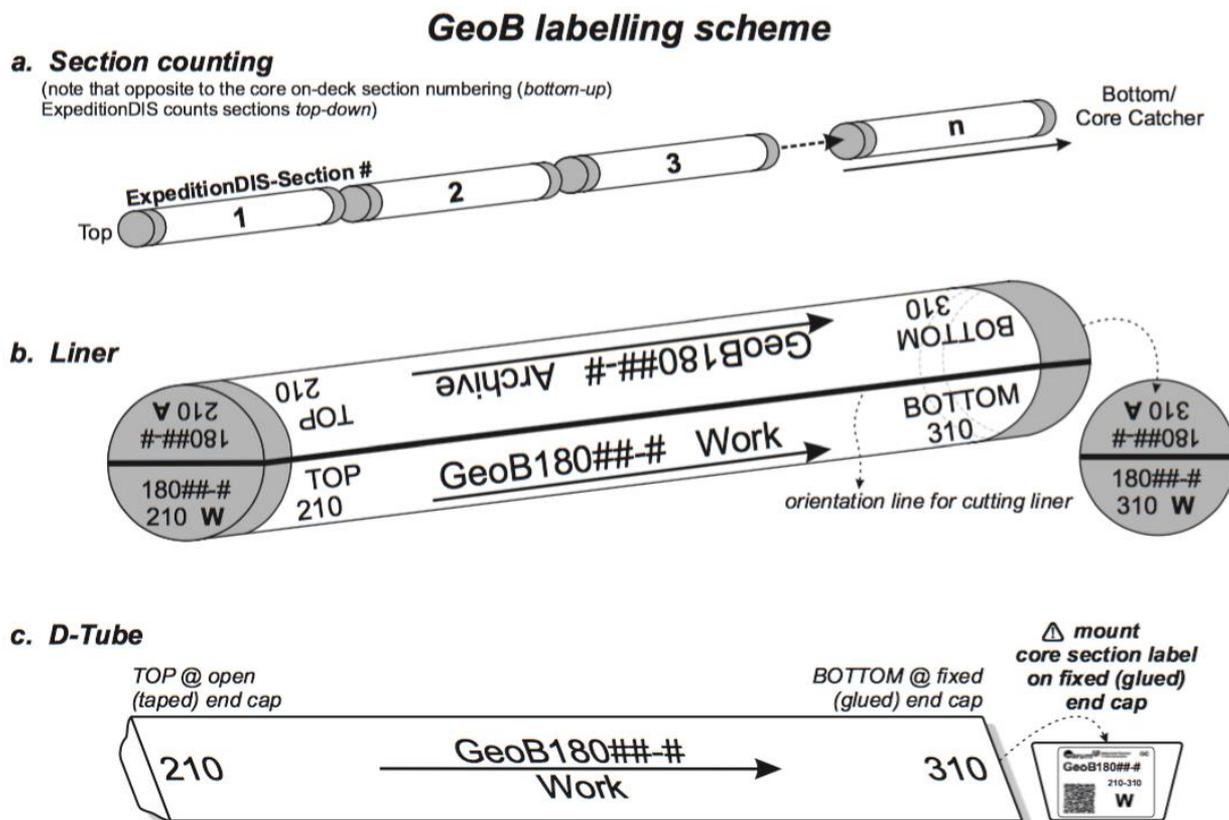
Figure 14 Inscription scheme of gravity core segments following the GeoB Standard.

After recovery the sediment cores were cut into sections of 1 m length on deck, closed with caps on both ends and labelled according to a standard scheme (Figure 14). The half core with the marked line was stored as archive half (AH), while description, sampling, etc. were carried out on the remaining half (working half [WH]). For the detailed procedures each working half core underwent, see below.

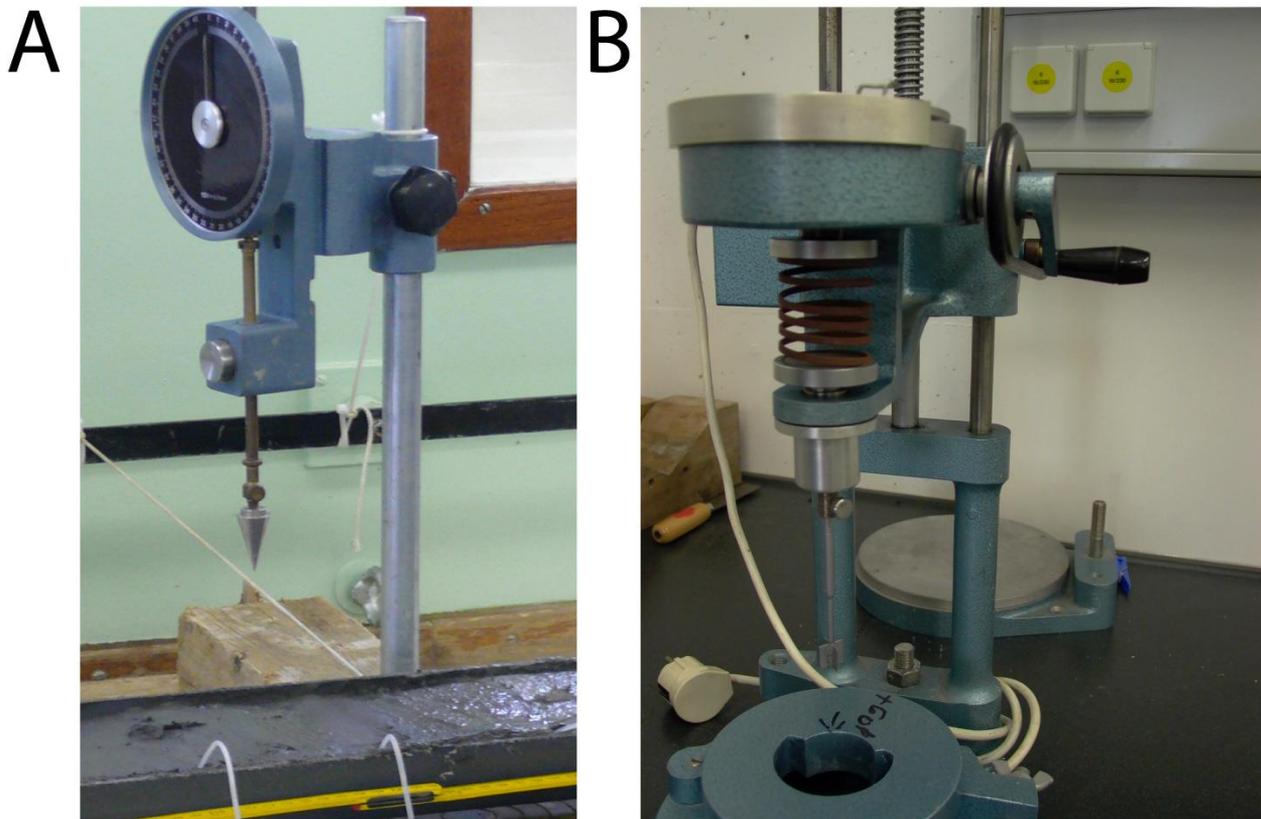
Figure 16 (A) Falling cone penetrometer and (B) vane shear device used on the split core surface.

The on-board investigation was limited to measurements of the undrained shear strength (s_u) using a fall-cone and vane shear device (Figure 16). The tests were realised on the working half of the sliced gravity cores. However in some cases the measurements were performed on the archive half of the cores in case the working half was disturbed by the slicing process. Fall-cone measurements were performed with a spatial resolution of 5 cm over the complete length of the core. Vane shear experiments are related to the lithologically interesting units (upper and lower boundary of the unit), which results in an average spacing of 33 cm.

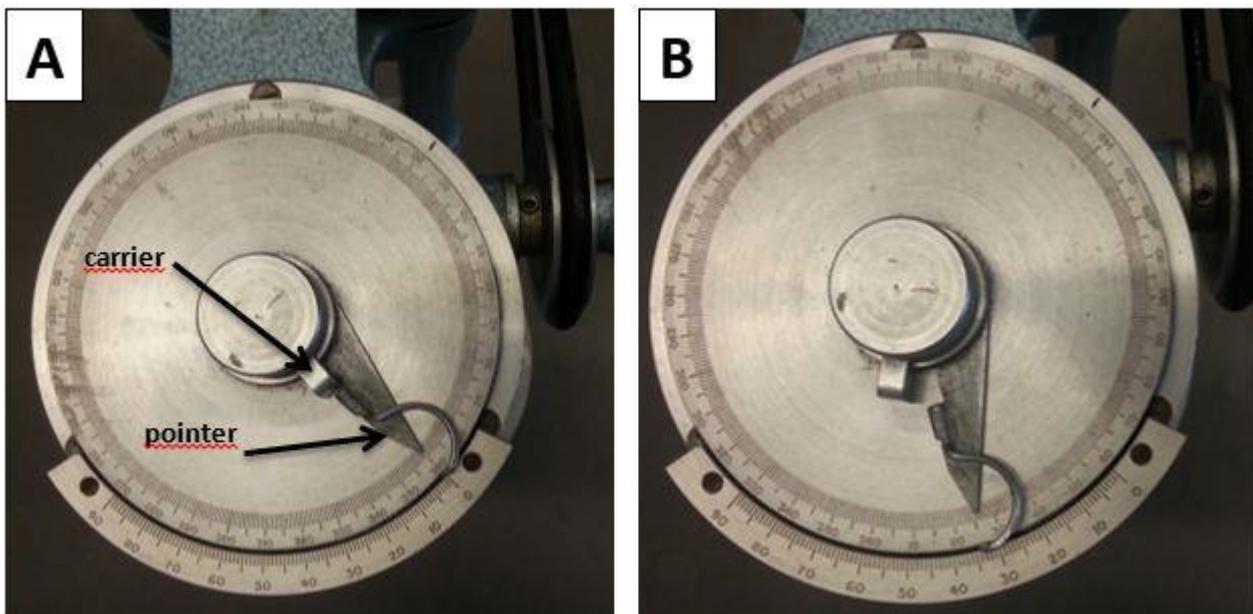
Figure 18 A shows the experiment setup: Inner scale 0° is placed on the outer scale 0°. Pointer starts at 0°/0° and touches carrier. B shows the setup after obtaining peak shear strength: Carrier does not touch any more the pointer and the pointer shows peak shear strength (inner scale).

The split core was placed below the vane and the pointer has to be in contact with the carrier. Afterwards the carrier is rotated by hand until the pointer is brought to zero on the inner scale. Then the handle is used to rotate the pointer to zero on the outer scale (Figure 18). Finally the top hand knob is used to lower the vane into the sediment core to a depth where shearing can take place on the horizontal edges of the vane (Controls Group 2007). When the sediment fails the torque angle of failure is measured in degrees on the inner scale. Therefore the calibration sheets (note that springs of different production series are related to different calibration sheets) provided by the manufacturer should be used to convert torque angle of failure into torque (T) which has the unit Nm. The equation below is used to calculate the undrained shear strength (c_u) in $N \cdot m^{-2}$,

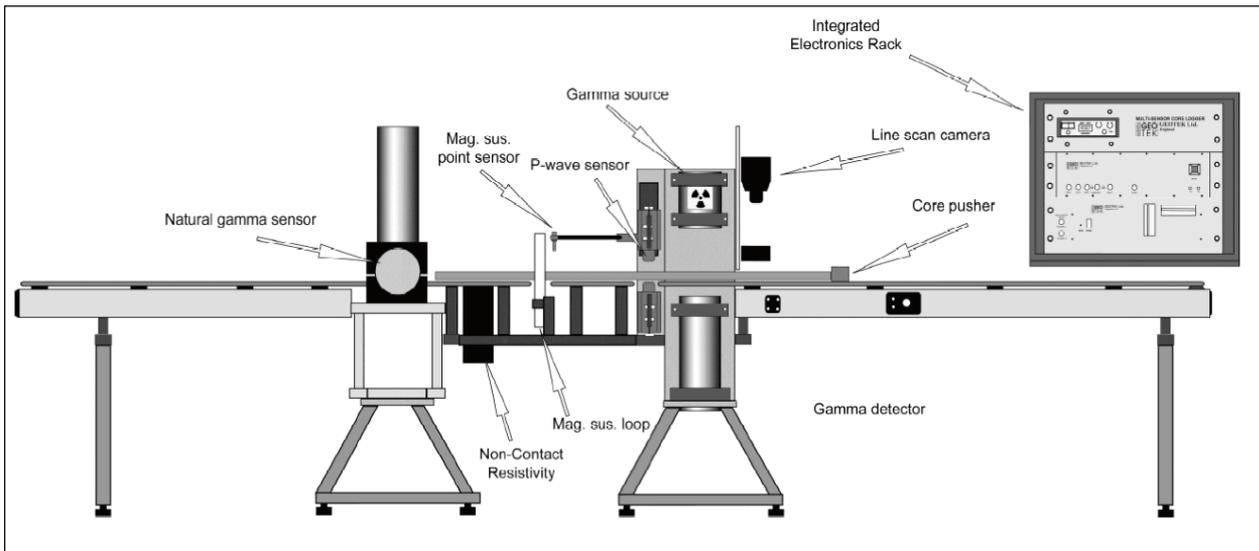
Figure 19 Schematic drawing of the Geotek Multi Sensor Core Logger (MSCL).

The GEOTEK MSCL device at MARUM Bremen combines three sensors on an automated track (Figure 19).

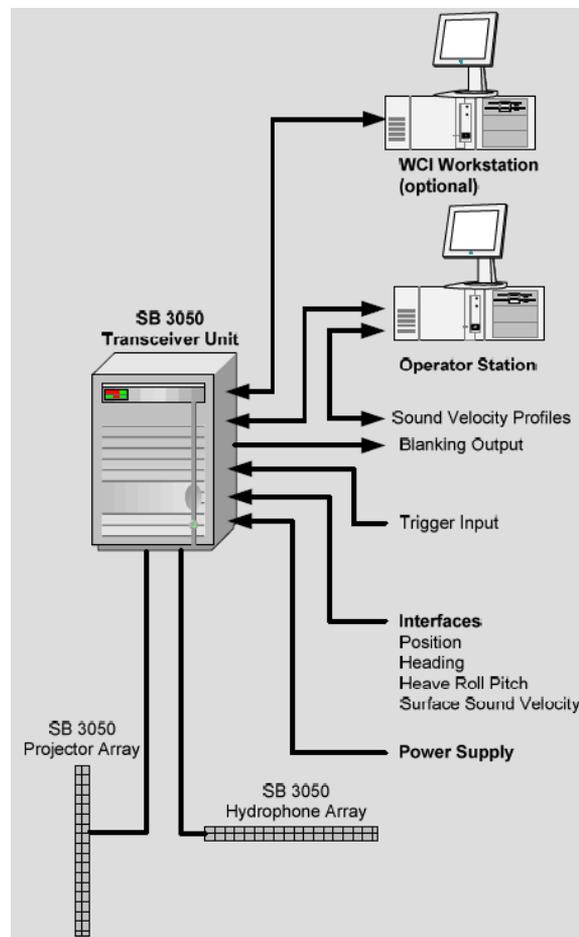
Figure 22 Layout of the Multibeam system recently installed on RV Poseidon.

The hardware components of the *Seabeam 3050* system include a motion sensor, a positioning system, a sound velocity profiler and a surface sound velocity sensor. An operating computer receives the preprocessed data stream. Bathymetric data can be visualised in real time using the *Hypack (2)* mapping tool. A schematic diagram of these different components can be seen in Figure 22.

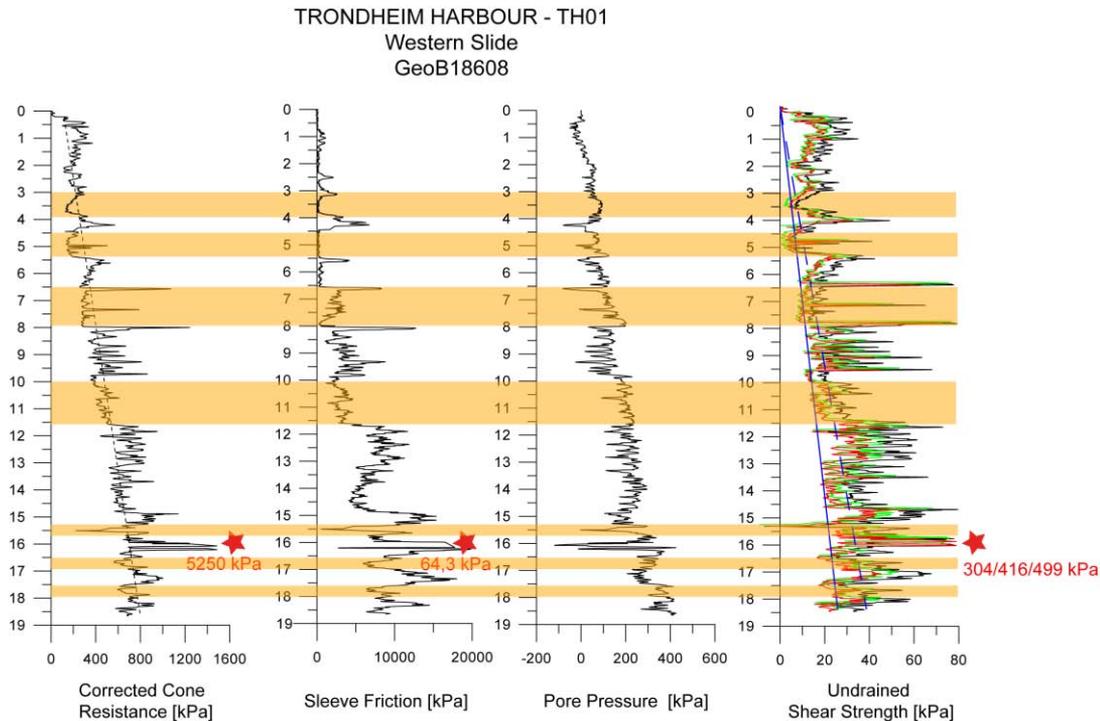
Figure 24 Data plot of the static CPTu profile GeoB18608. Red-coloured stars mark data peaks, which have been clipped for better illustration. The number specify the value of the peak. Blue lines indicate the ratio of undrained shear strength over the depth of the profile (continuous line: s_u ratio = 0.2; dashed line: s_u ratio = 0.3, see Chapter 6.1.1))

The CPTu profile GeoB18608 at site TH01 characterises the non-failed portion behind the W'Slope on the plateau in between the Nidelva channel system (Fig. 23). The corrected cone resistance q_t reflects well interbedded strata comprising i) the background sediment, which increases linearly up to ~800 kPa at 19.5 mbsf, ii) stiff layers with q_t -values up to 5.25 MPa, and iii) material, where q_t decreases relatively and indicates a certain loss of sediment-mechanical strength. In accordance to q_t , these portions reveals low values of sleeve friction f_s (Figure 24). These portions are highlighted by orange-colored corridors in the plot (Figure 24). Pore pressure measurement indicates no zone of overpressure. High values of q_t coincides with significant loss of pore pressure. This is the typical signal for dilative shearing behaviour when the CPTu penetrates coarser-grained or overconsolidated sediment.

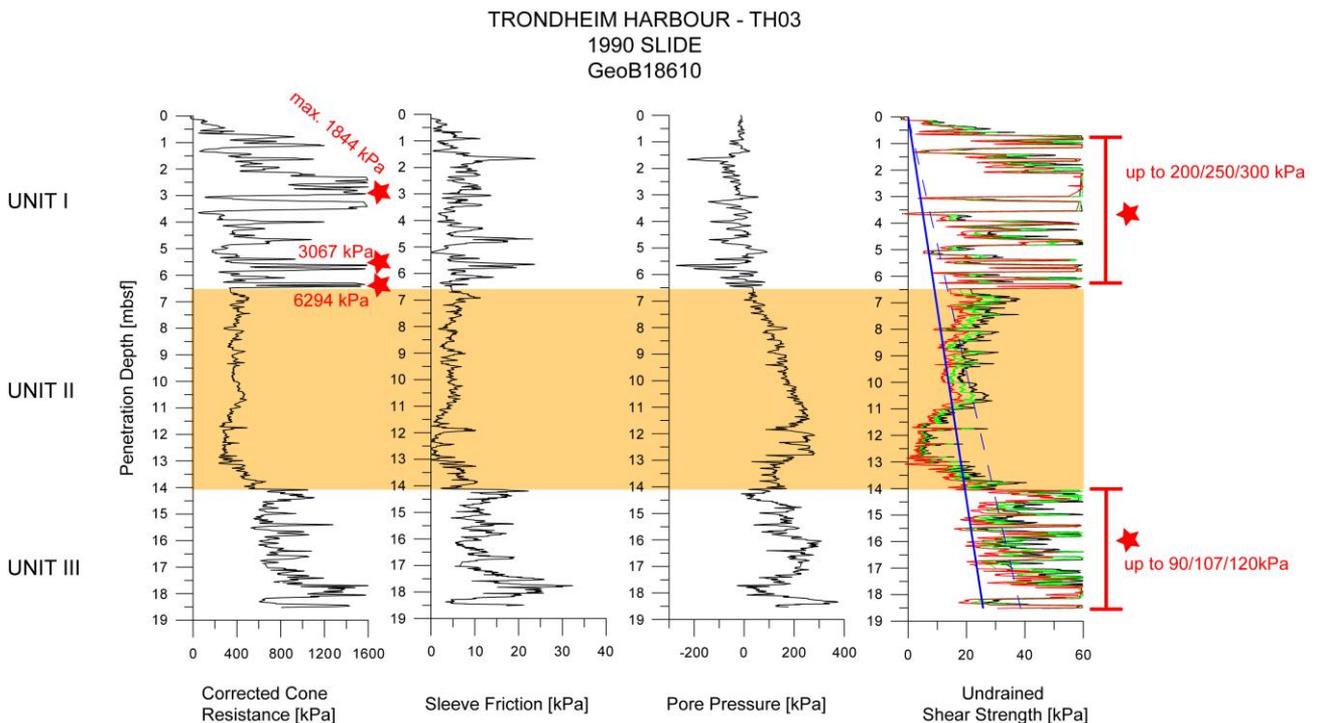
Figure 25 Data plot of the static CPTu profile GeoB18610. Red-coloured stars mark data peaks, which have been clipped for better illustration. The number specify the value of the peak. Blue lines indicate the ratio of undrained shear strength over the depth of the profile (continuous line: s_u ratio = 0.2; dashed line: s_u ratio = 0.3, see Chapter 6.1.1))

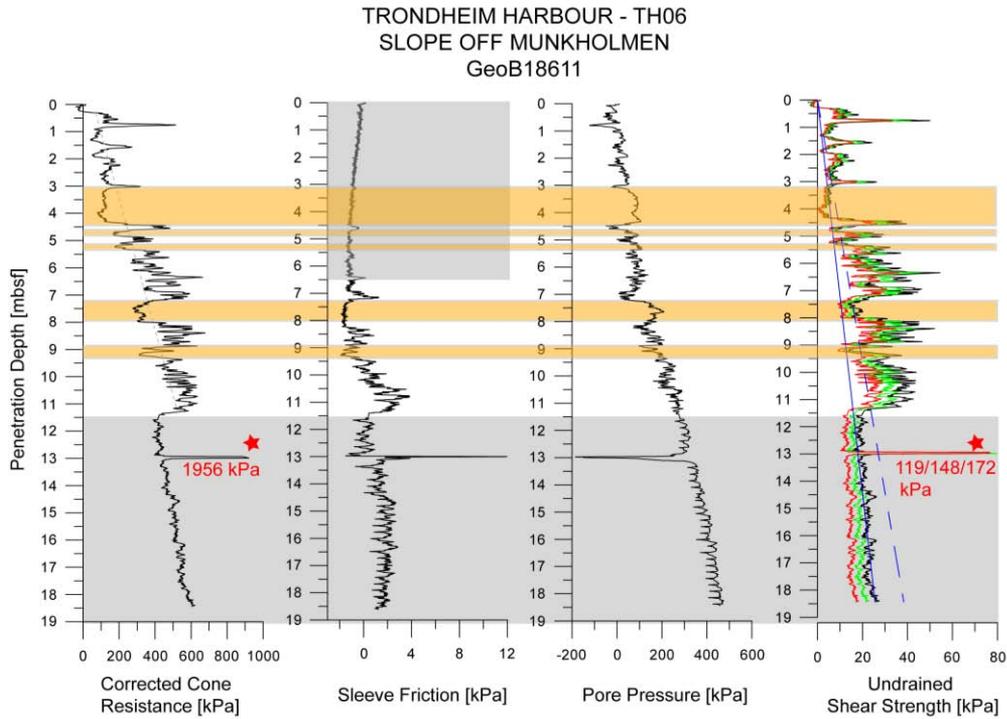
Figure 26 Data plot of the static CPTu profile GeoB18611. Red-coloured stars mark data peaks, which have been clipped for better illustration. The number specify the value of the peak. Blue lines indicate the ratio of undrained shear strength over the depth of the profile (continuous line: s_u ratio = 0.2; dashed line: s_u ratio = 0.3, see Chapter 6.1.1))

CPTu profile GeoB18611 is located on a submarine terrace between the western flank of the Island Munkholmen and the Nidelva channel in the East (see Figure 23). Penetration depth was 18.5 mbsf. Penetration depth was 18.5 mbsf. Quality of the GeoB18611 data is limited: i) The tiltmeter recorded an inclination up to 90° in the upper section (up to 10 mbsf). But no bending or breaking of the rods has been observed. ii) q_t , f_s as well as u show no reliable data underneath 10 mbsf (Figure 26). Cause for this data is not reproducible, as the GOST system worked well after recovery.

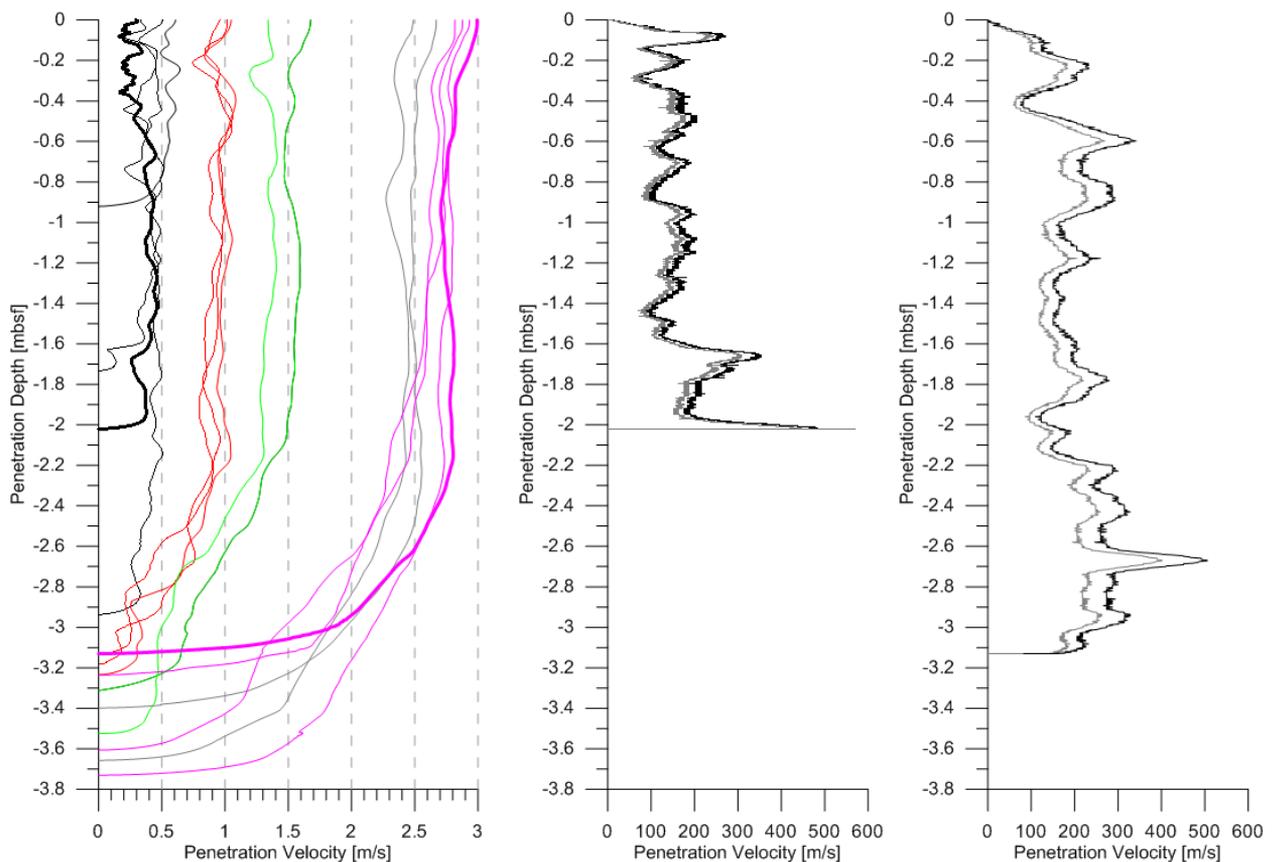
Figure 27 Rate-dependence CPTu testing with the FF-SW-CPTu lance at site TH01. A) Illustrations of the various initial penetration rate (0.5, 1.0, 1.5, 2.5 & 3 m/s), which was used for the 16 dynamic CPTu drops, and the resulting penetration depth. For each “velocity group” the CPTu deployment was carried out four times. This plot contains only successful deployments. B) Difference between rate-corrected and non-rate-corrected values of cone resistance for different initial penetration velocities. Profiles shown here are highlighted in panel A by a heavy line.

Penetration depth ranged from 0.9 mbsf and 3.7 mbsf (Figure 27). The variability of penetration depth increased for the deployments with $v = 0.5$ m/s (black-coloured lines, 0.9 mbsf – 2.9 mbsf) and $v = 3$ m/s (purple-coloured lines, 3.1 mbsf – 3.7 mbsf).

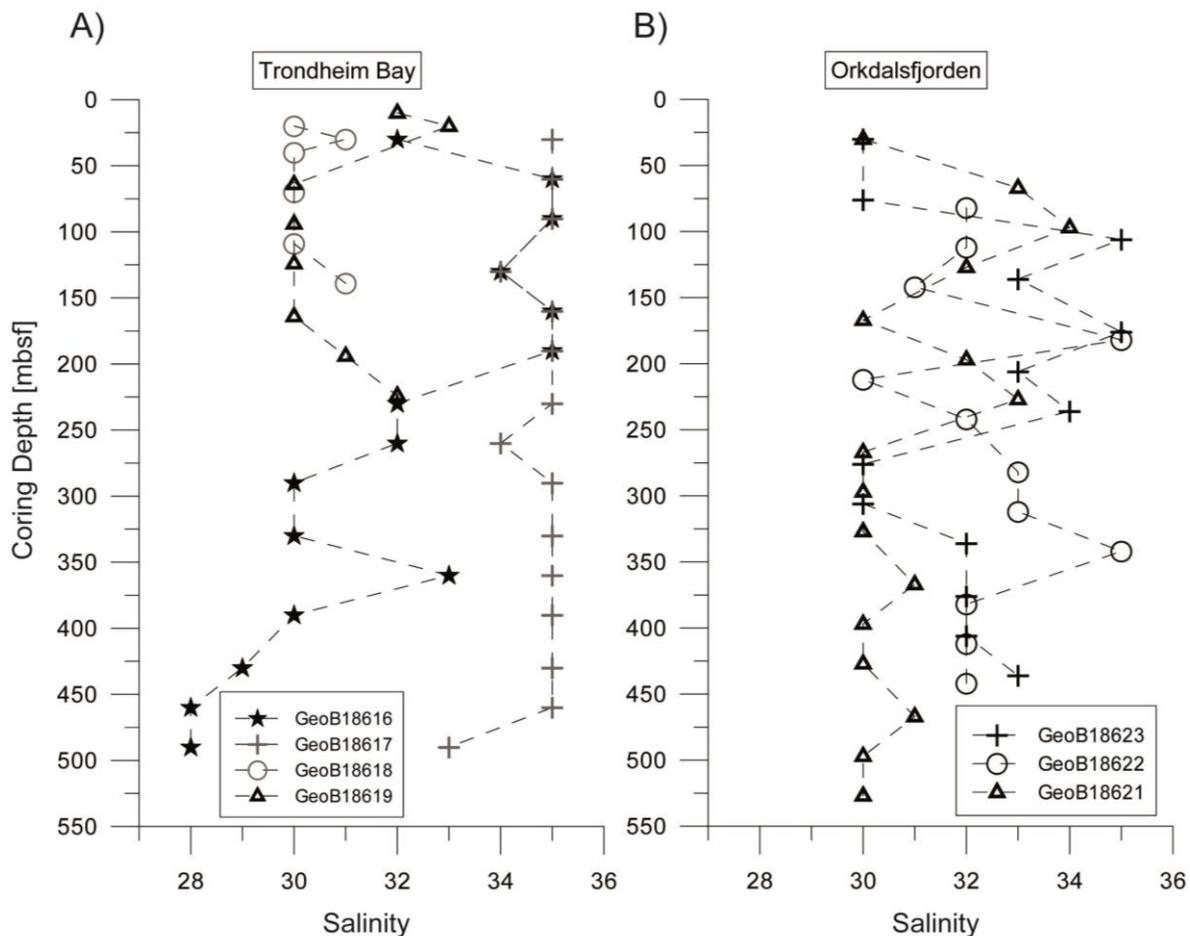
Figure 28 Values of salinity measured on pore fluids extracted from gravity cores taken within the Trondheim Bay and Orkdalsfjorden.

First-order determination of salinity of extracted pore fluids using a handheld salinity refractometer reveal freshening of fluids within the core taken nearby the coastline (GeoB18616, -18, -19, Figure 28A). Here values of salinity decrease up to 28 ‰ minimum in core GeoB18616 at site TH01. Salinity of pore fluids obtained from Core GeoB18617, located at the western flank of the island Munkholmen attest sea water conditions (salinity ~ 35 ‰). Further geochemical analyses will be carried out in the MARUM laboratory.

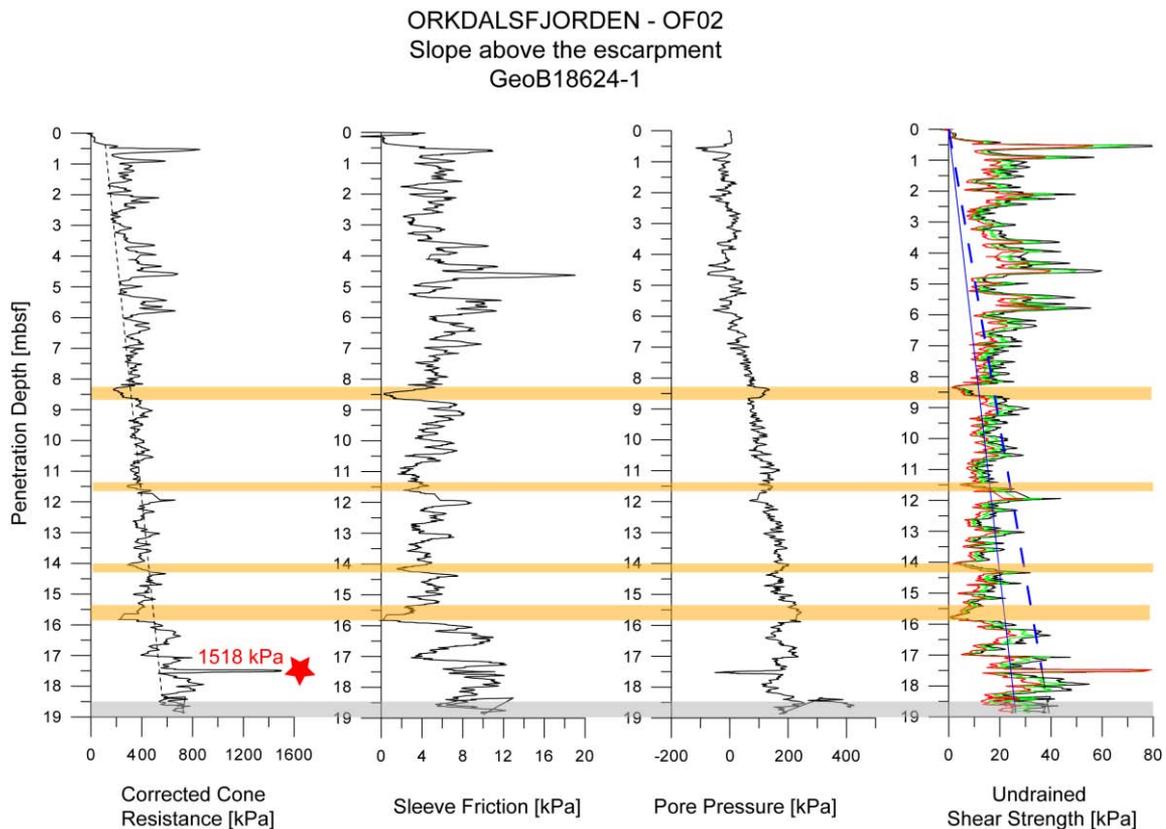
Figure 30 Data plot of the static CPTu profile GeoB18624-1. Red-coloured stars mark data peaks, which have been clipped for better illustration. The number specify the value of the peak. Blue lines indicate the ratio of undrained shear strength over the depth of the profile (continuous line: s_u ratio = 0.2; dashed line: s_u ratio = 0.3, see Chapter 6.1.1). Orange-coloured bar represents mechanically relative weaker layers defined by decreasing q_t .

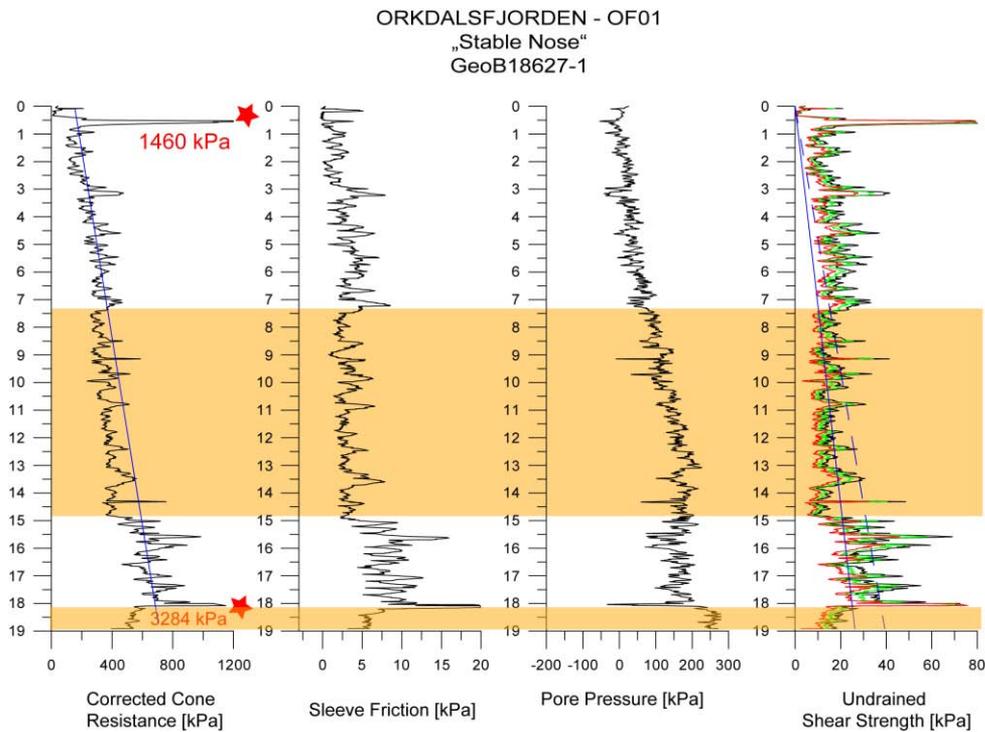
Figure 31 Data plot of the static CPTu profile GeoB18627-1. Red-coloured stars mark data peaks, which have been clipped for better illustration. The number specify the value of the peak. Blue lines indicate the ratio of undrained shear strength over the depth of the profile (continuous line: s_u ratio = 0.2; dashed line: s_u ratio = 0.3, see Chapter 6.1.1)). Orange-coloured bar represents mechanically relative weaker layers defined by decreasing q_t .

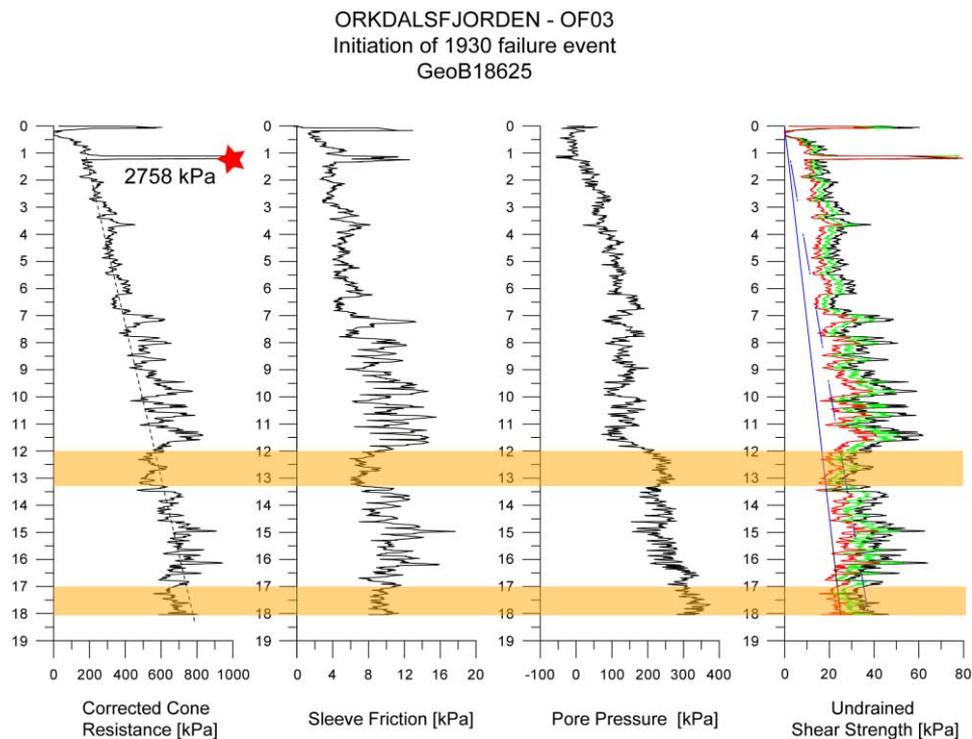
Figure 32 Data plot of the static CPTu profile GeoB18625. Red-coloured stars mark data peaks, which have been clipped for better illustration. The number specify the value of the peak. Blue lines indicate the ratio of undrained shear strength over the depth of the profile (continuous line: s_u ratio = 0.2; dashed line: s_u ratio = 0.3, see Chapter 6.1.1)). Orange-coloured bar represents mechanically weaker layers defined by decreasing q_t .
