REPORT AND PRELIMINARY RESULTS OF R/V POSEIDON CRUISE POS472

NORGEOTECH

GEOTECHNICAL IN SITU INVESTIGATION OF SLOPE STABILITY IN
NORWAY

TRONDHEIM (NORWAY) – TROMSØ (NORWAY)
27.07.2014 – 12.08.2014

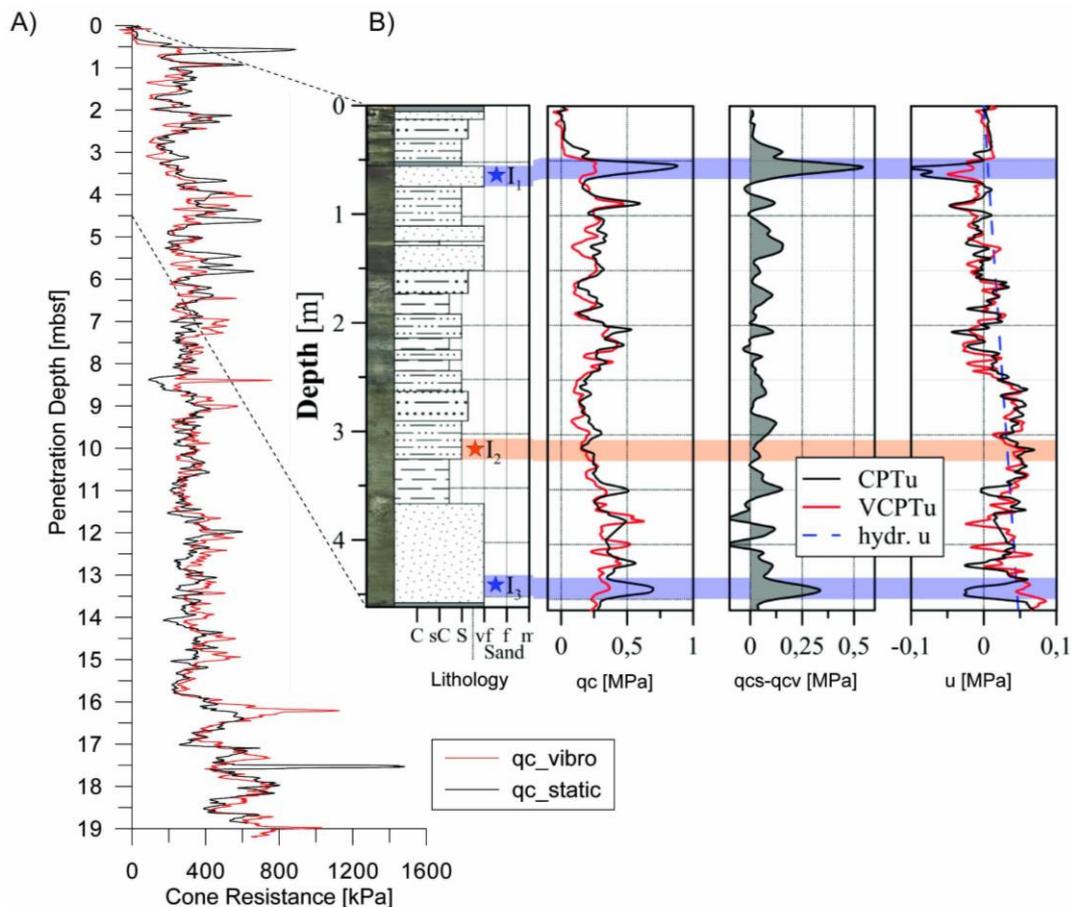
Figure 33 Initial data from CPTu and VCPTu test using the GOST system: A) Profile of cone resistance over the complete penetration depth. The plot compares the static cone resistance (black line) with the vibro cone resistance (red line). B) In a generic study by Kluger et al. 2014 the in situ data are combined with soil index properties and compared to results of cyclic undrained triaxial tests. In order to relate q_{cs} and q_{cv} , Sasaki et al. (1984) proposed The reduction ratio $RR = 1 - q_{cvibro}/q_{cstatic}$ is used to relate $q_{cstatic}$ and q_{cvibro} (Sasaki et al. 1984). Higher RR values indicate an increase of liquefaction potential.

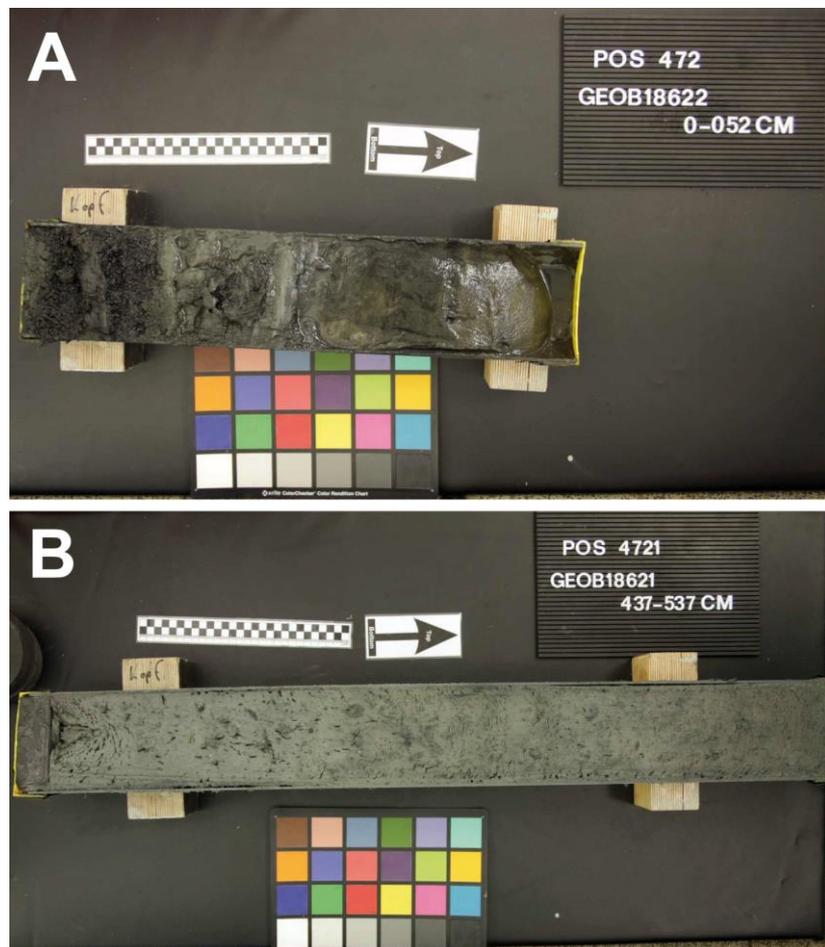
Figure 34 A) Anthropogenic input from the metal industry at Thamshavn (see L’Heureux et al. 2014); B) Deformation structures related to escape of gas, when the core was split.

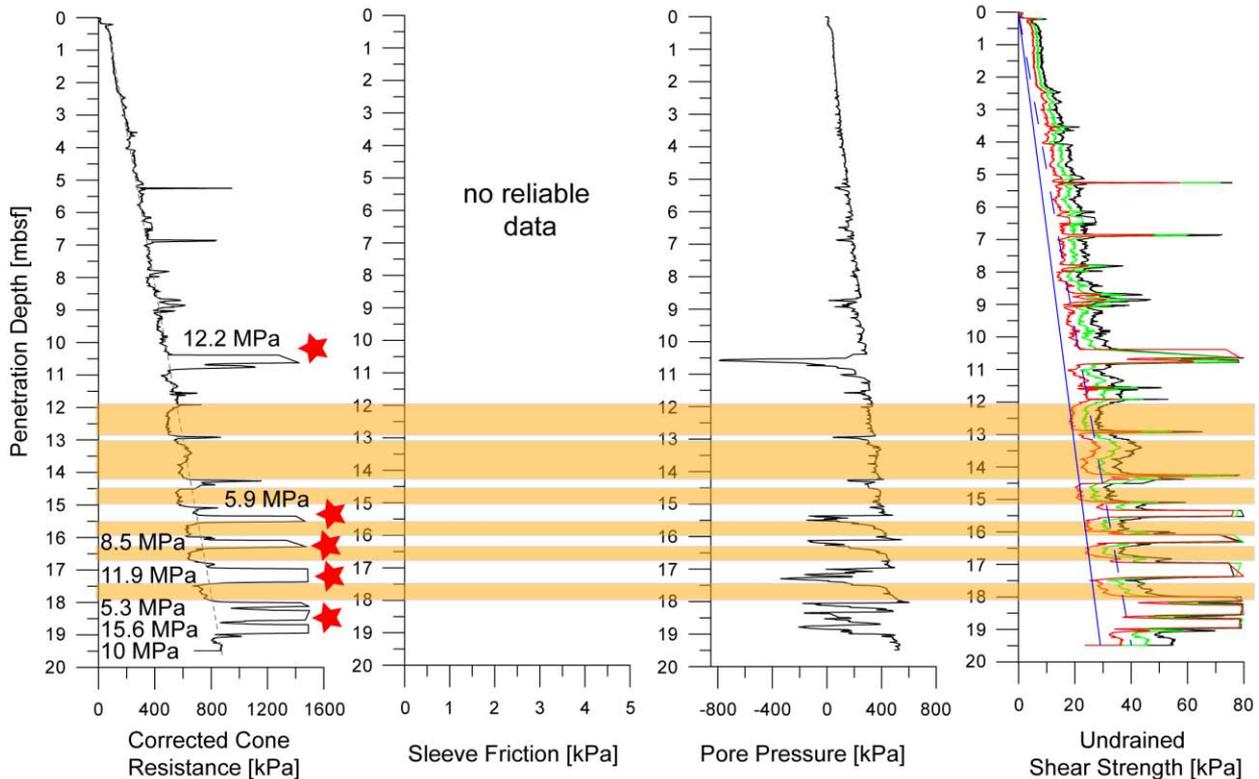
Figure 36 Data plot of the static CPTu profile GeoB18638. Red-coloured stars mark data peaks, which have been clipped for better illustration. The number specify the value of the peak. Blue lines indicate the ratio of undrained shear strength over the depth of the profile (continuous line: s_u ratio = 0.2; dashed line: s_u ratio = 0.3, see Chapter 6.1.1))
